EPILATUSE
B4

**MAINTENANCE
AND REPAIR
MANUAL**

DOC.NO. 23-11-00-01482

PILATUS B4-PC11

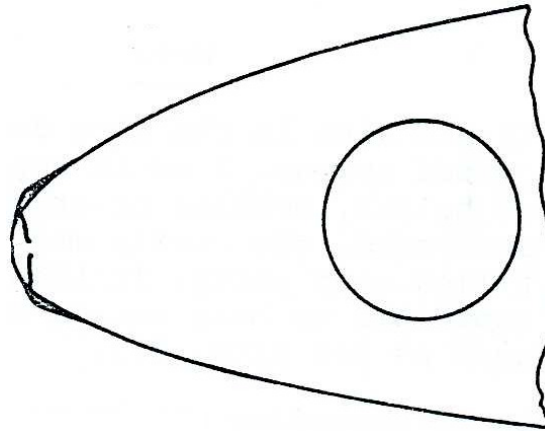
Section A-A

Fig. 4b Rework

- (c) Tools as illustrated in Fig. 4b.

- Drill a hole of approx. 6 mm dia. into the dented nose section (Fig. 4a).
- With the aid of a hook pull out the dent, while hammering down the bulges (Fig. 4b).
- Remove the paint coat around the repair area using paint remover or by sanding down to bare metal. Residual primer may remain.
- Smooth out the hole in the nose section which has been enlarged during repair, using a round file or emery cloth. Enlarge the hole to approx. 1/2" if necessary, round or oval shaped.
